USACERL Technical Report 95/02
May 1995

Thermal Energy Supply Optimization for Aberdeen Proving Ground-Edgewood Area

Distribution System Condition Assessment and Recommendations

by
Vicki L. Van Blaricum, Charles P. Marsh, and Vincent F. Hock

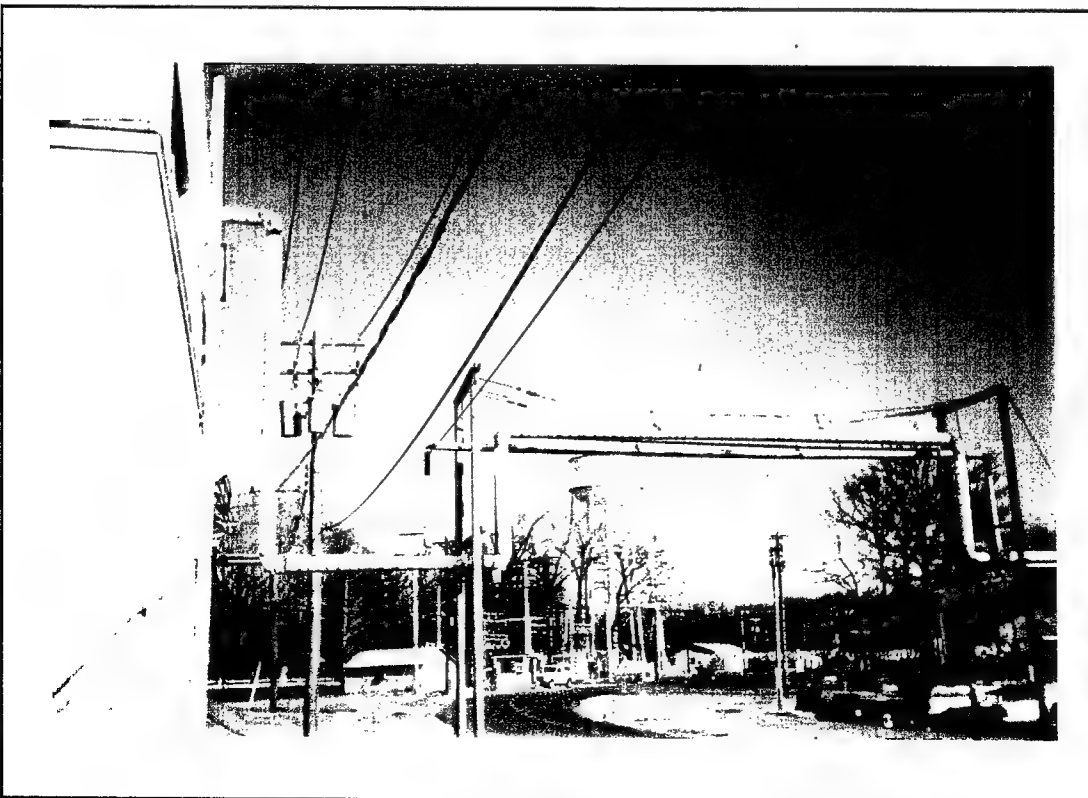
An estimated 2,000 ft of aboveground piping, ranging from 2 to 6 in. in diameter, was found to be without insulation. In addition, there are numerous sections (such as that shown in Figure 1) where insulation and insulation covering are damaged. Missing insulation is particularly a problem at pipe elbows. Figure 2 shows an example of this.

Figure 2. Typical example of missing insulation on pipe elbows near Bldg E3312.

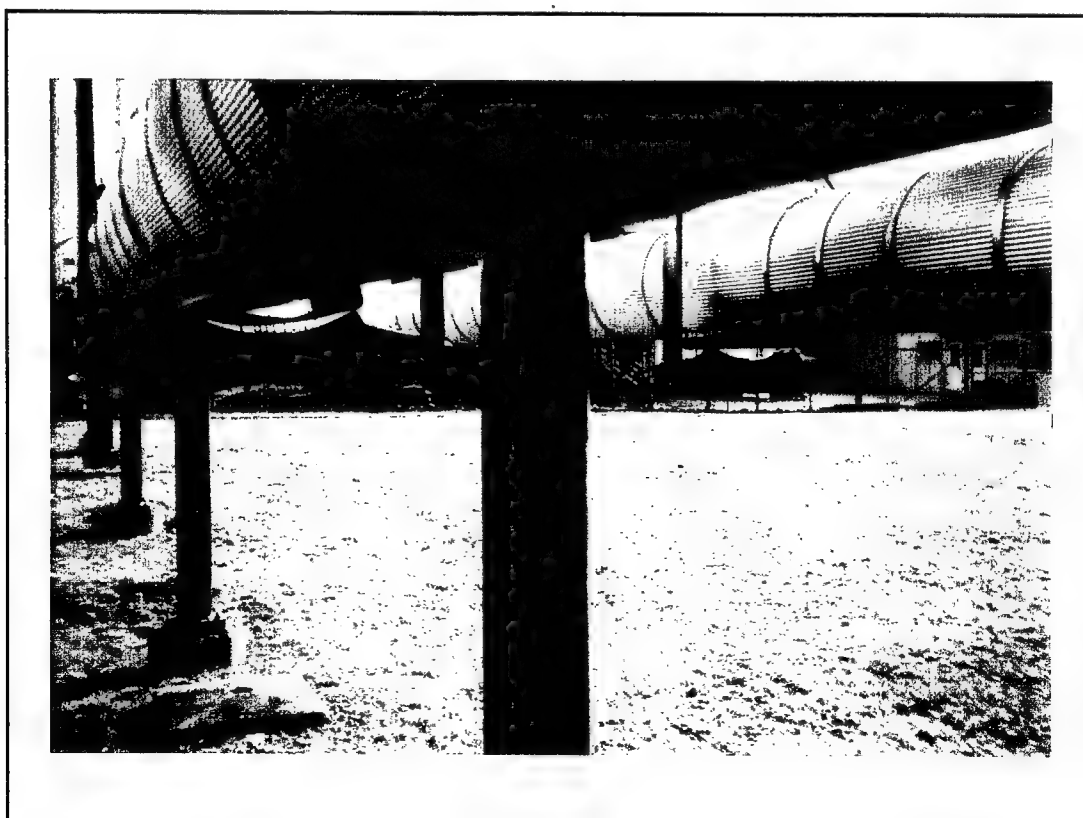
Figure 5. Typical example of pipe not resting properly on support rollers on line to Bldg E3570.

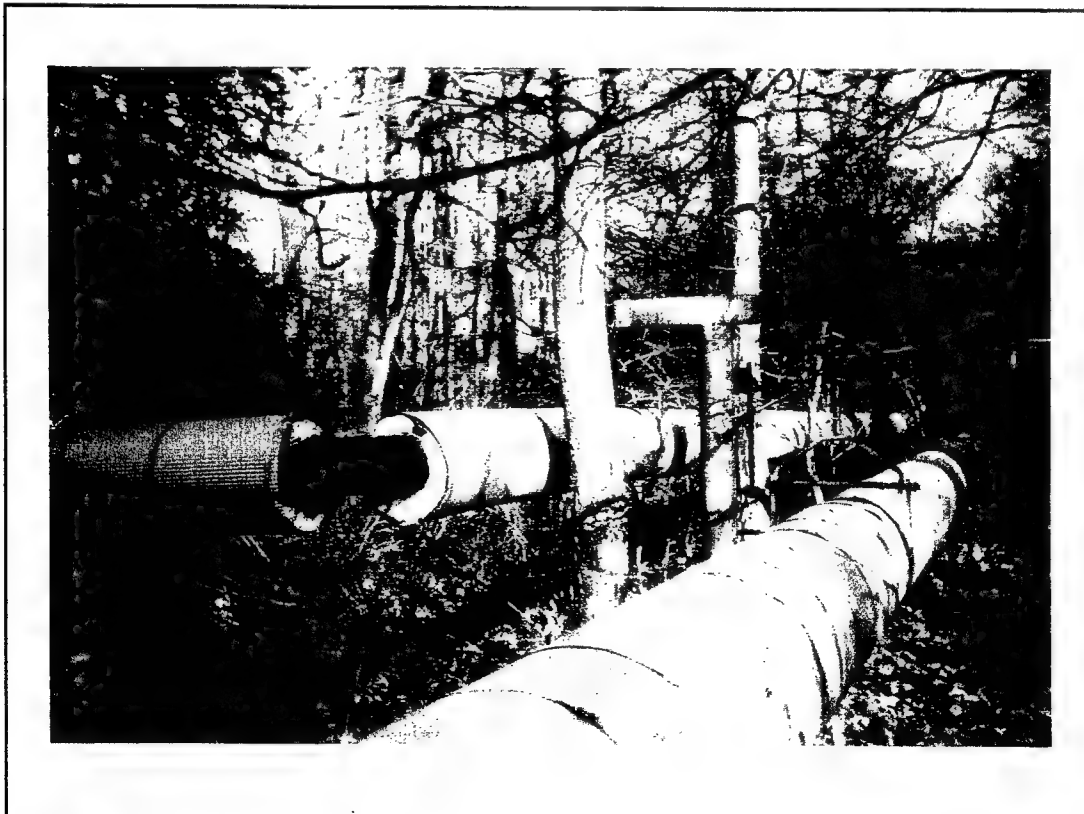
from the outside. This observation was supported by the fact that most leaks were on the top area of the pipe. If corrosion was being caused by the condensate acting from the inside, most of the leaks would appear along the bottom of the pipe. Most likely, the severe corrosion along this section is due to wet insulation at the pipe surface. The steam lines were in fair condition. In addition, there was excessive vegetation, including several trees, growing between the steam and condensate line (Figure 7). This vegetation should be removed. Areas of missing insulation were also observed (Figure 8).

Figure 8. Trees growing between lines and missing insulation on pipe elbows on Section 3312-37A.
